High volume water and mud ingress in early 2020 halted Lötschberg rail traffic to investigate, clean up and repair the lining breach

Lötschberg water breach repair complete

Feb 2021

Shani Wallis, *TunnelTalk*

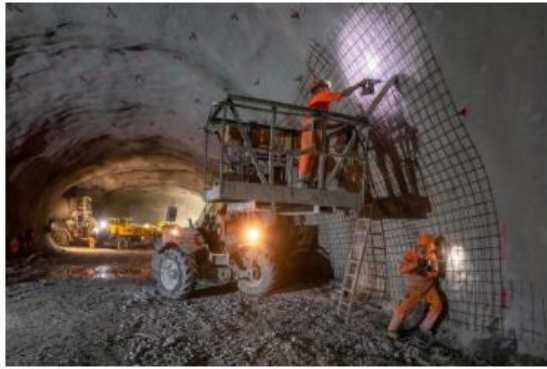
Primary support in the cavern topheading

During the works, the east tube of the operating railway was closed, with trains either diverted to other lines or running in a managed bi-directional operation in the west tube alone, providing 24hr/day, 7 day/week access for the works. Drill+blast excavation of the cavern progressed on a topheading and bench sequence with muck transported out via railbound works trains through the Raron portal about 2km to the south. The existing operating tracks at the works site were covered with temporary backfill to permit excavators and drilling equipment traffic. "It was a logistical challenge to get all the materials in and out of the tunnel by train," reported Stefan Irngartinger, the works Project Manager for BLS, "but with experience, logistics ran very well." According to Irngartinger, there were only minor water inflows from joints during excavation, with a 10cm karst joint encountered at the north end of the cavern. Blasting vibrations had to be well controlled to permit train operations in the west tunnel at about 40m parallel.

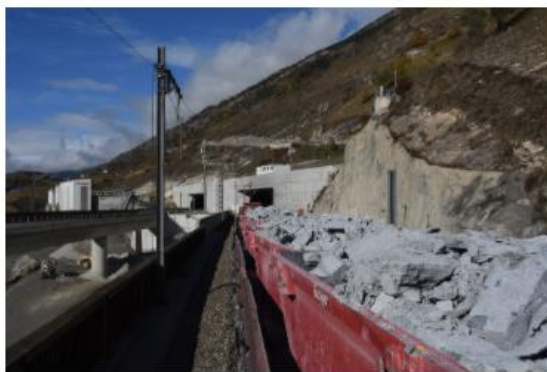
Access provided via the closed east tube from the Raron portal of the railway

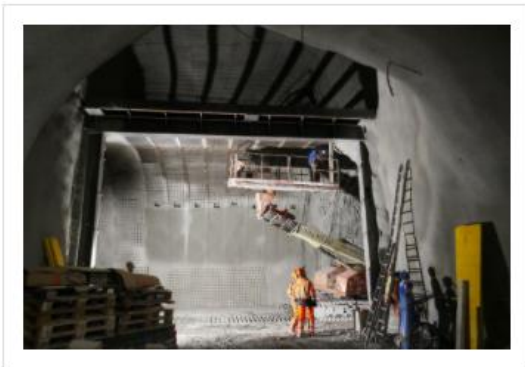
Finalising work at the breakout adit junction with the main running tunnel

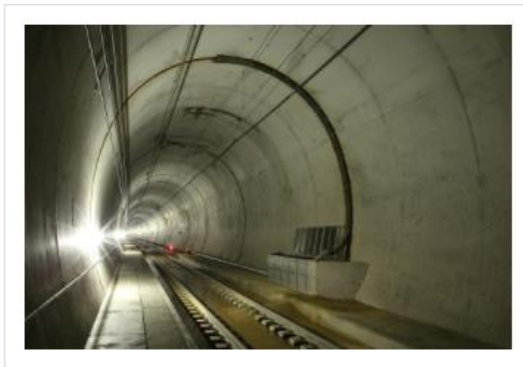
Temporary sedimentation tanks in the east running tunnel ahead of the permanent works

The permanent solution for continuing safe operation of the railway and management of the geological ground water hydrology within the overburden is to breakout of the existing east tube running tunnel at two points and excavate a cavern to house a set of water and sedimentation settling tanks. The cavern, with its sloping invert, is 89m long x 11.40m wide x 5.7m to 11.50m deep and the settling basin has a capacity of more than 2,000m³ from which settled water will continue to be channelled to the surface outside the south Raron portal of the railway and from there into the River Rhone, which passes about 400m from the portal. Sediment will be cleared regularly as it builds up (Fig 1). As an immediate remedy in the east tube, BLS installed a steel sedimentation tank in the affected area to permit rail traffic until closed again for the cavern excavation works.
